6. AUTHOR(S) D. J. Chang and H. A. Katzman		5d. PROJECT NUMBER		
		5e. TASK NUMBER		
		5f. WORK UNIT NUMBER		
7. PERFORMING ORGANIZATION NAME(S) AND ADDRESS(ES) The Aerospace Corporation Laboratory Operations El Segundo, CA 90245-4691		8. PERFORMING ORGANIZATION REPORT NUMBER TR-2003(1413)-1

Strength Degradation of Filament-Wound Graphite/Epoxy Tubes Due to Either Impact Damage or Fabrication Defects

1 August 2004

D. J. CHANG and H. A. KATZMAN
Space Materials Laboratory
Laboratory Operations

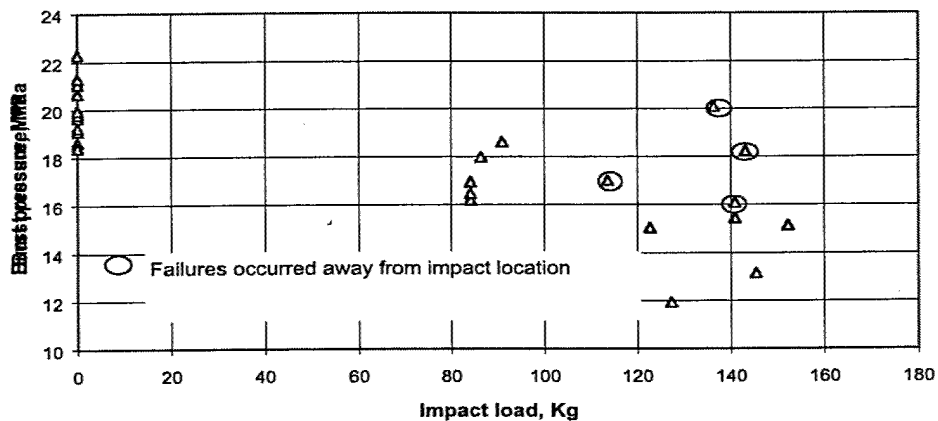
The impact loads typically produced damage consisting of one or two visible line cracks. Photographs of a typical crack are shown in Figure 6. The cracks ran either in the longitudinal or in an off-axis direction. They were typically 1.3 to 1.9-cm (0.5 to 0.75-in.) long depending on the magnitude of the impact. Figure 7 shows the burst pressure as a function of impact load. It shows that the burst pressure decreases significantly with increasing impact force. For impact loads of 823 to 1470 newtons (N) (185 to 330 lb), the burst pressure dropped by as much as 24% to 32%, respectively, compared to the burst pressure of tubes with no impact damage.

Figure 7. Burst pressure versus impact load.
